# Manhole Inspection Summary

Manhole # S35CC2009MH

Insp Date: **3/30/07 9:50 AM**

**Location** Address: **5922 BELLONA AVE**

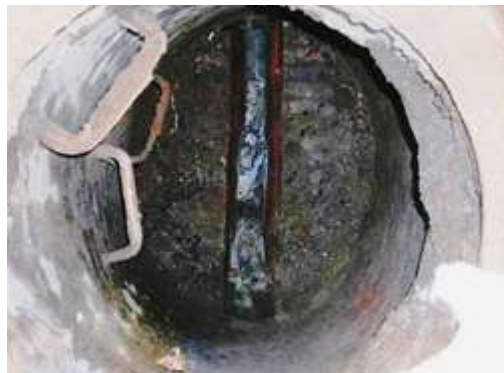
Top View

Corroded steps. Evidence of surcharge - Bench debris. Channel debris.

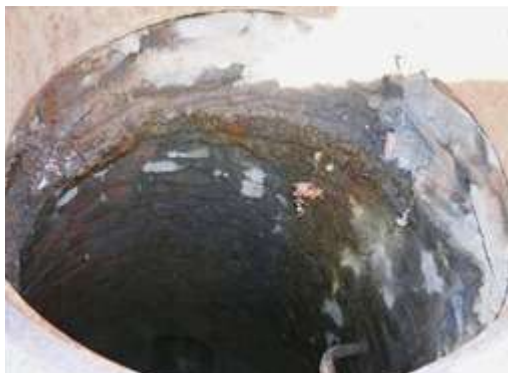
Defect

Adjustment deterioration and infiltration. Corbel and Barrel infiltration - other side.

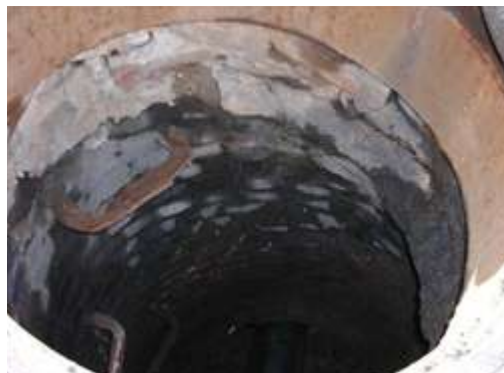
Defect

Frame leaks. Adjustment deterioration and infiltration. Corbel and Barrel infiltration.

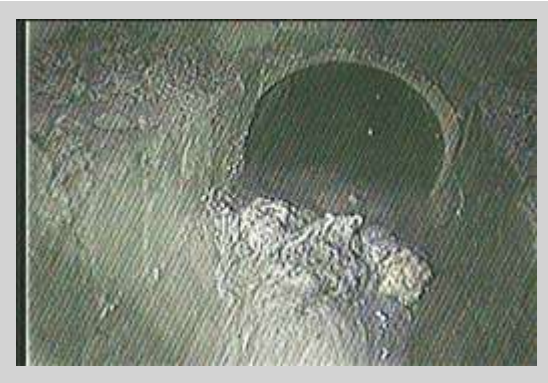
### 8 in. Circular Gravity Sewer Pipe Out @ 12 O'Clock

Barrel deterioration and infiltration. Channel deterioration.

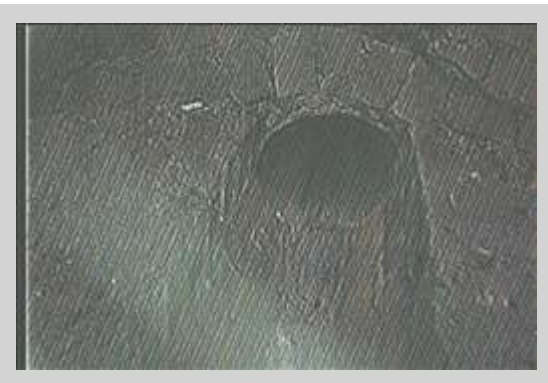
### 8 in. Circular Gravity Sewer Pipe In @ 6 O'Clock

Barrel deterioration and infiltration. Channel deterioration.

Infiltration: **Evidence** Pipe Seal Cond: **Cracked**
